BREATHING LIFE INTO EXISTING STRUCTURE - ENHANCING SAFETY OF A CHEMICAL PLANT

Aishwarya Gupta
Sr. Project Engineer
NVLN Constructions Pvt. Ltd.

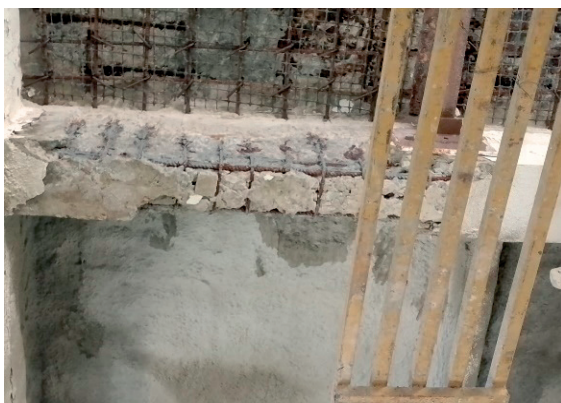
The chemical plant in question exhibited multiple distress signals, including exposed corroded reinforcement, dampness, leaching, spalling, and cracks in concrete surfaces. These deteriorations posed significant risks to the structural stability, necessitating a thorough investigation and rehabilitation strategy.

Fig. 1: Distress in structural element

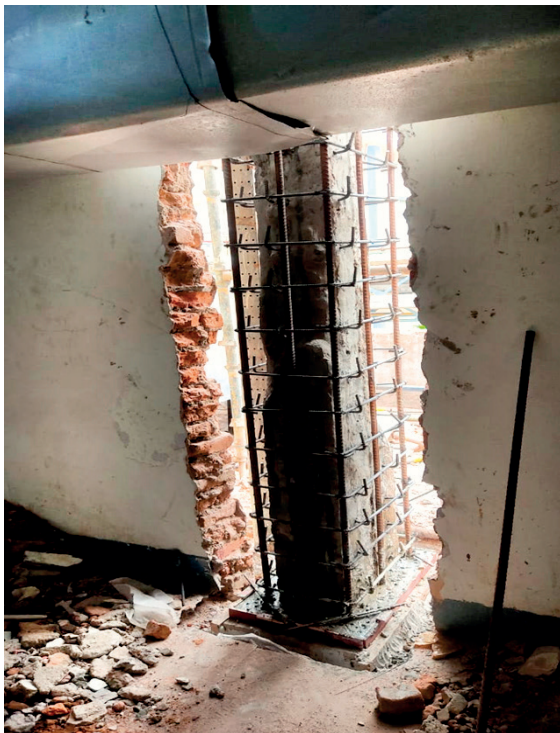
Fig. 3: Concrete Jacketing of Column

For the columns, a similar approach was taken with some key differences. First, the load on the existing columns was reduced by temporarily supporting the structure. Then, the column surfaces were roughened, cleaned, and a bonding agent was applied for good adhesion. The columns were encased with a 100 mm thick layer of reinforced concrete.

For longitudinal reinforcement, six 20 mm diameter bars were used, crucial for carrying the axial load and ensuring structural integrity. Transverse reinforcement involved 8 mm diameter bars, serving as shear keys and ties, spaced at 150 mm center-to-center. These bars resist shear forces and prevent diagonal cracking and buckling.

A clear cover of 40 mm was maintained to protect the reinforcement from environmental effects and ensure durability. Finally, non-shrink cementitious micro-concrete was used for encasing, chosen for its low shrinkage properties to minimize thermal cracking. This combination of materials and reinforcement ensures the strengthened columns can effectively support the structure while maintaining durability and safety.
