# SEISMIC

ACADEMY

Journal

September  
2025

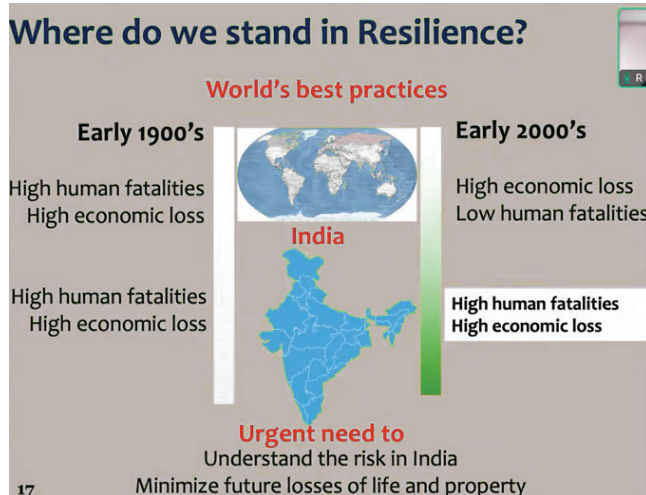
Risk is the combination of hazard, vulnerability, and exposure. Hazard and exposure together are referred to as threat.

In spite of all the technological advancements which have happened in the field of engineering over the past decades, both high human fatalities and high economic losses still persist because of multiple reasons. There is an urgent need to better understand earthquake risk and take necessary steps to minimize future losses to life and property.

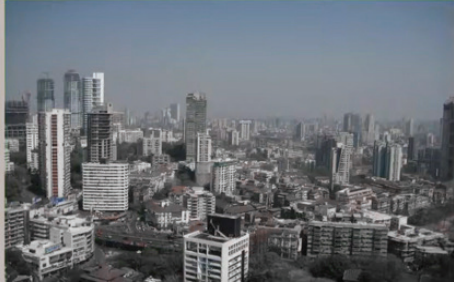
## 1. Strategic Installation of SMAs

- Prioritize the deployment of SMAs in the IHR and urban centers for better hazard modeling and real-time response.
- IS16700-Cl 11.1 recommends
  - All tall buildings in seismic zone V
  - Buildings Exceeding 150 m in Zone III, IV

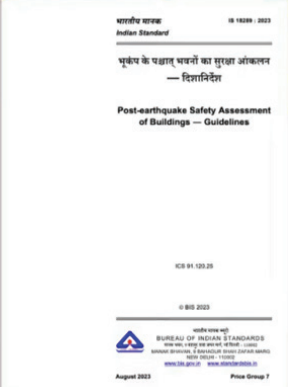
- **Leverage AI and remote sensing for real-time damage assessment post-earthquake.**

Currently, this process is done manually and there is a scope for automation. Drone-based surveys can be used to quickly assess large numbers of buildings, significantly speeding up the process.

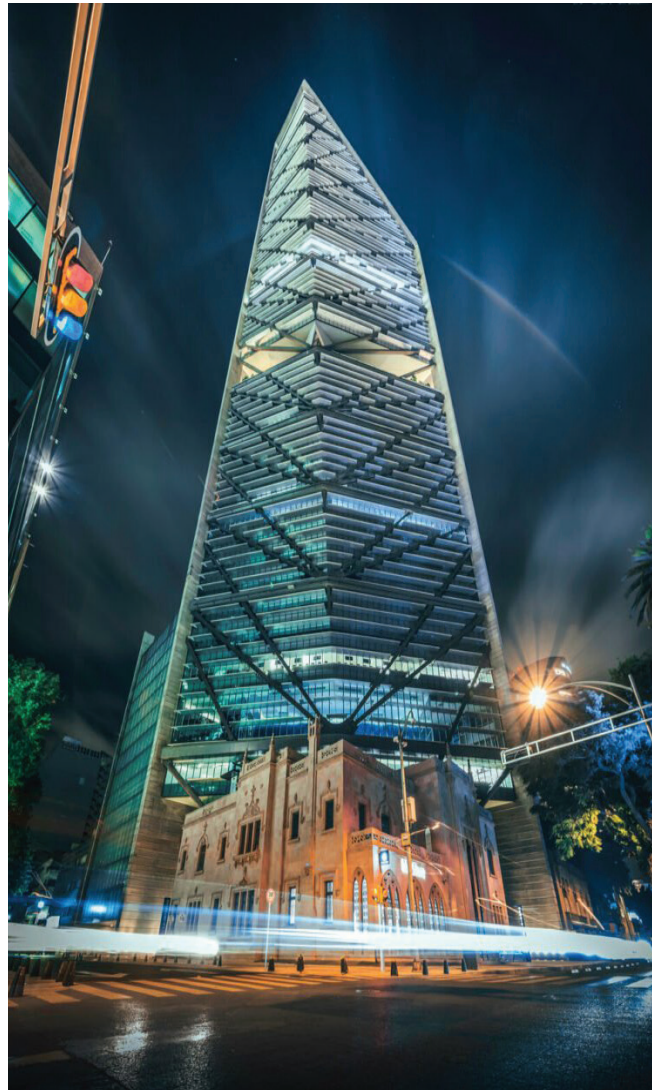
Torre Reforma's sharp, three-sided profile called for bespoke seismic solutions. On its upper floors, steel cross-bracing membranes tie the façades together, keeping the tower stable during tremors. The analysis undertaken to support the building's structural

scheme utilized non-linear material behaviour to explicitly measure the dissipation of seismic energy. It confirmed that the structure would be undamaged during a service-level seismic event and that life safety would be preserved, even under the extreme case of maximum considered earthquake event (2475 year return period).
