Vol. 07 | December 2024

Seismic Academy Journal

Post-Repair Assessment of Load-Carrying Capacity of the Ashulia Bridge

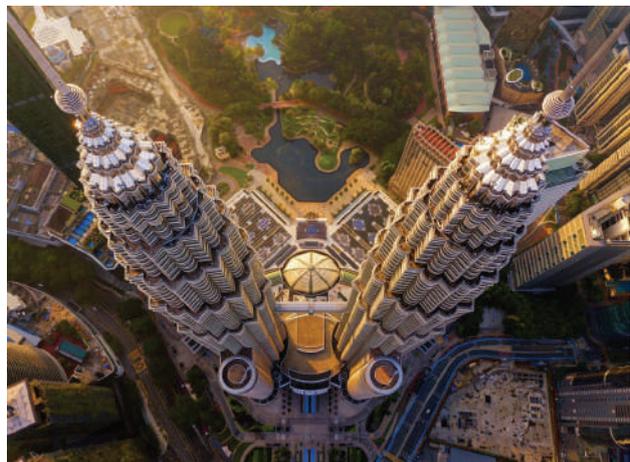
The construction of the Petronas Towers was a massive undertaking that required the collaboration of architects, engineers, and builders from around the world. The towers were built using the “slipform” technique.

The towers were built on a soft soil foundation, which posed a significant engineering challenge. The foundation system consisted of a 4.5-meter-thick piled raft supported on rectangular friction piles, varying in depth from 40 meters to 105 meters and each foundation consisted of 104 barrettes.

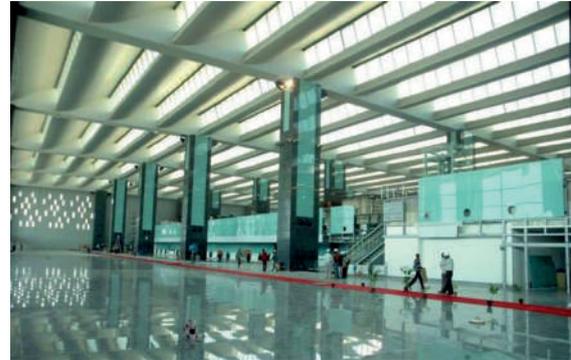
Fig. 2: Framed system: Terminal building at Bangalore airport

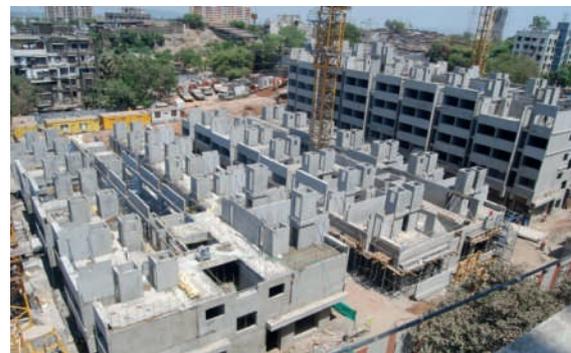
Fig. 3: Large panel system: High-rise apartment buildings at Mumbai

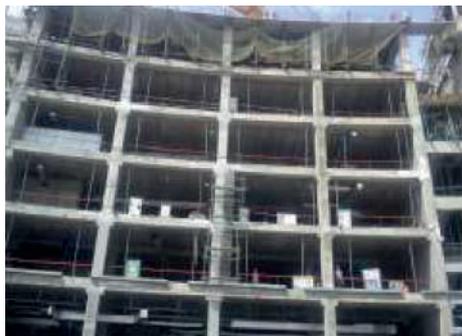
Fig. 4: Case Study 1: Canteen building with hollow core slab system

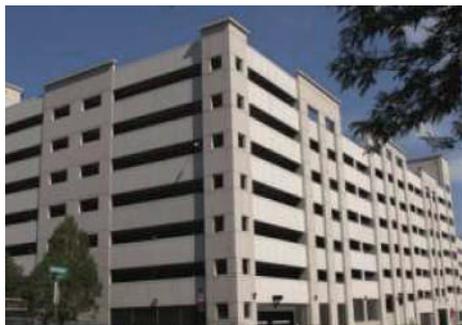
Fig. 5: Case Study 2: Multi-level vehicular parking garage

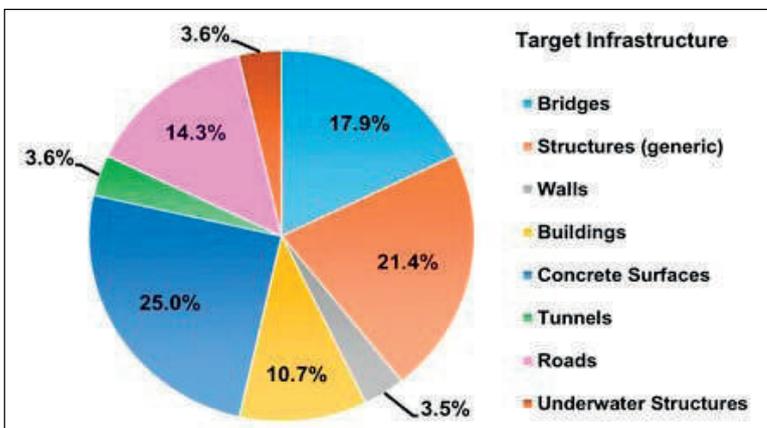
1(a). Percentage distribution showing type of infrastructures studied

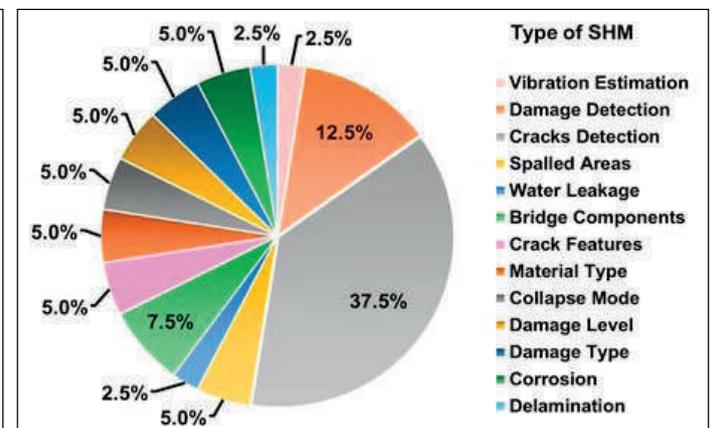
1(b). Percentage distribution showing structural traits monitored

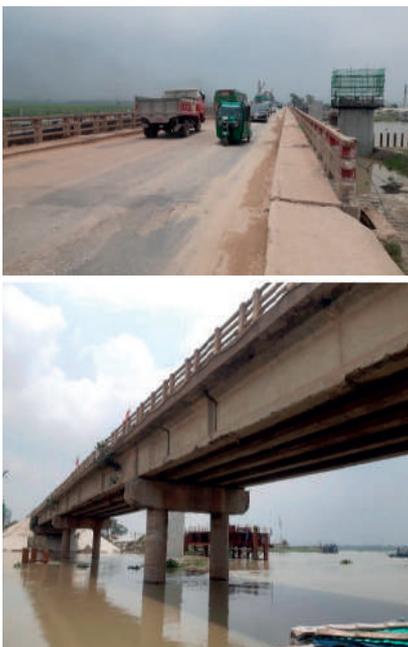
Fig. 1: (a) Top and (b) side view of the bridge

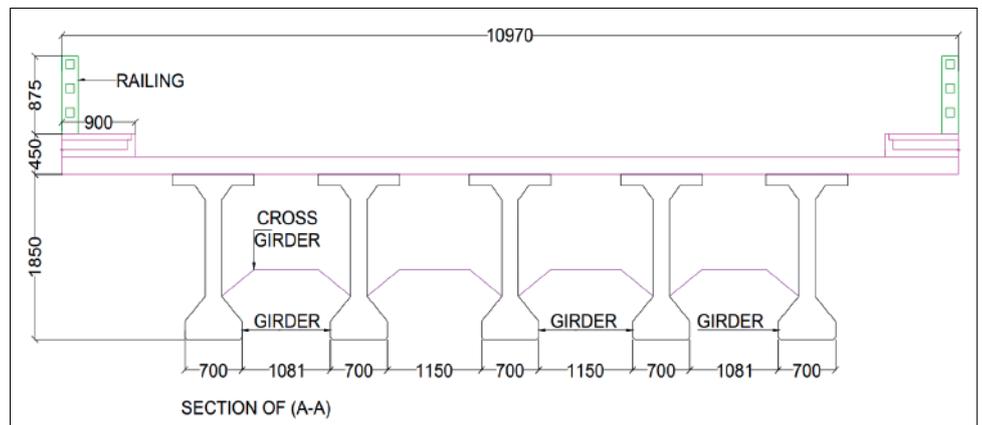
Fig. 3: Cross-sectional view of the span

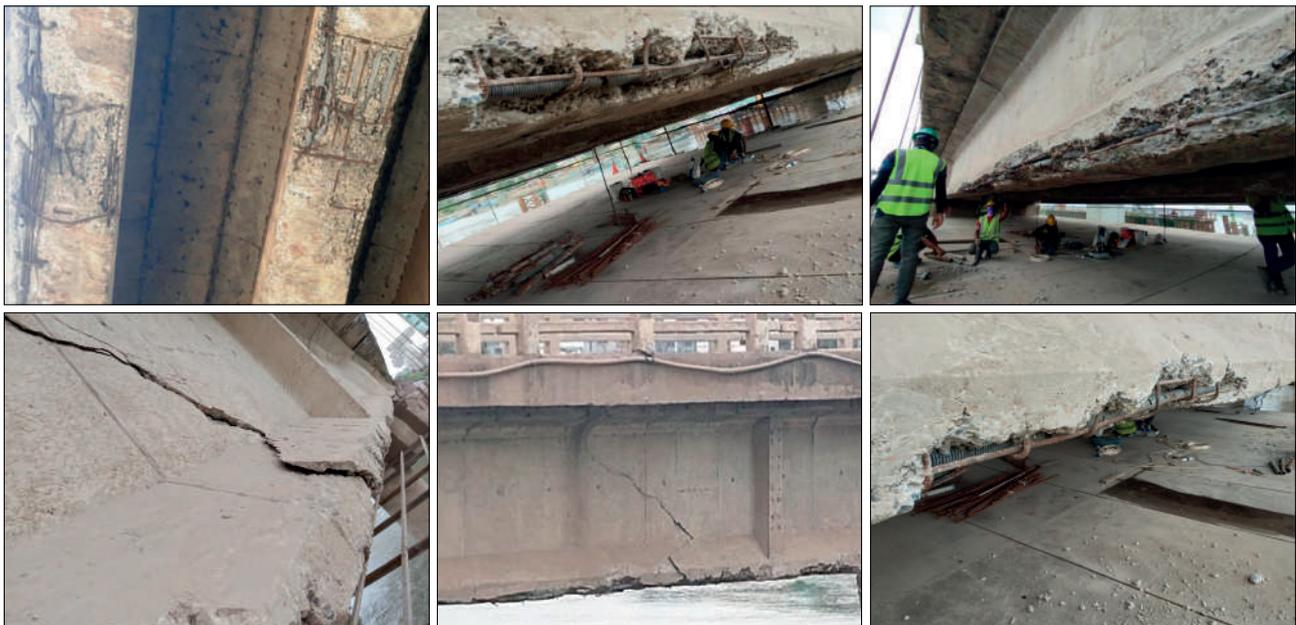
The first girders on the north side sustained severe damage due to a collision with an over-height navigation vehicle. Fig. 5 shows different views of the damage. Significant concrete spalling occurred on the first girder near mid-span, exposing internal reinforcement and tendons. Similar spalling was also observed on

Fig. 5: Extent of damage from the field observation

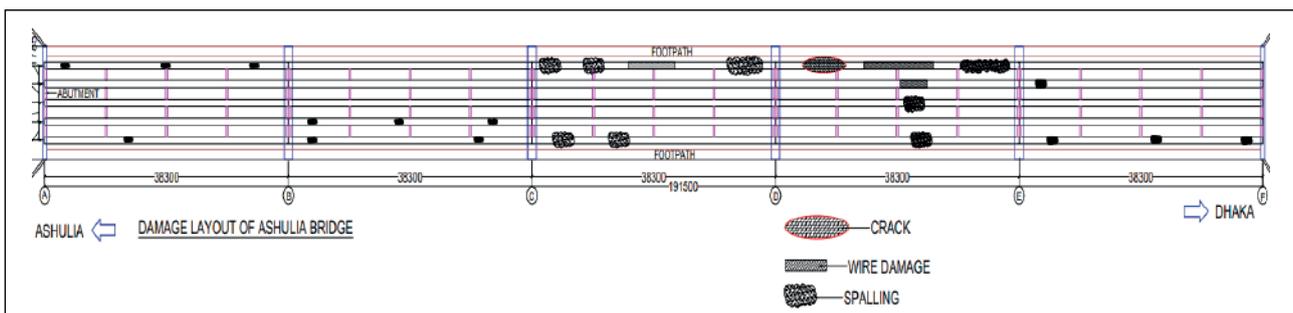
Fig. 6: Schematic view of the damage and cracking of the concrete

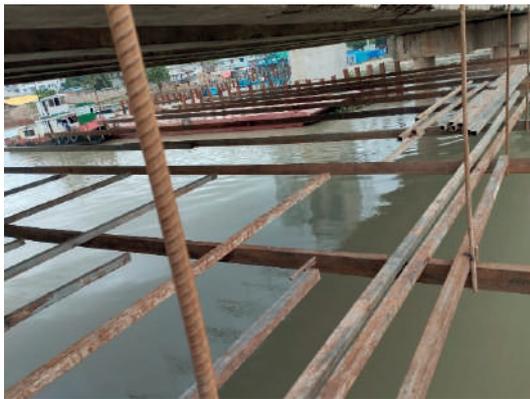
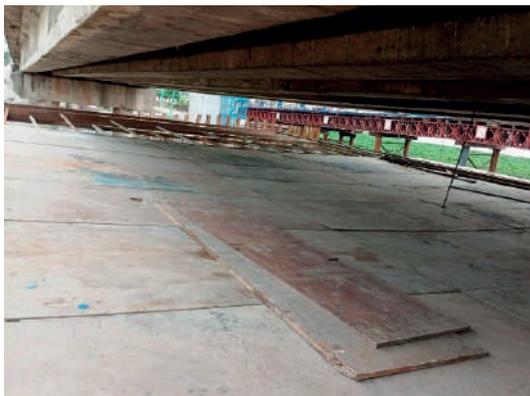
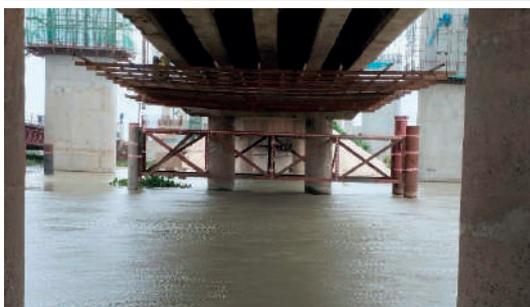
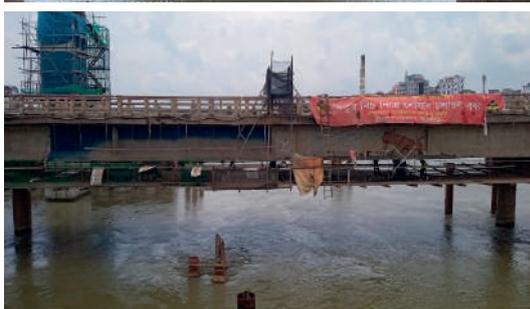
- **Step 1 (Suspended Staging):** A suspended scaffolding has been installed beneath the bridge to facilitate repair and load testing work. Fig. 7 shows the suspended staging for under-bridge repairs.

Fig. 7: Suspended Staging for Under-Bridge Repairs

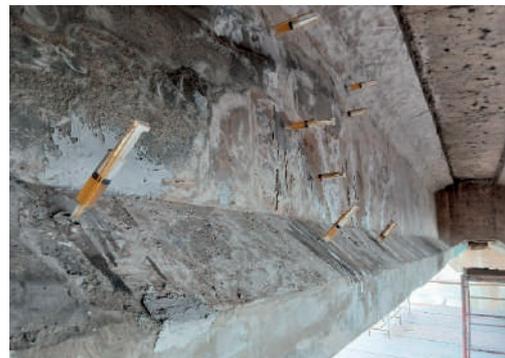
Fig. 8: Crack Repair by Epoxy Injection

- **Step 2 (Repair of Cracks and Spalling of Girder and Pier Cap):** The repair of spalling in the girder and pier cap was carried out using patch repair mortar or micro-concrete. The process began by identifying spalling locations and chipping out all loose concrete. The rebar was then inspected for corrosion; if corrosion was found, section loss was checked. If the section loss was below 20%, the rebar was retained; otherwise, it was replaced with a new rebar. Concrete behind the corroded rebar was removed, ensuring at least 20 mm was cleared, and rust was cleaned from all sides of the rebar while confirming any diameter loss. A zinc-rich coating was applied to prevent further corrosion. For repairs less than 50 mm thick, repair mortar was used, and for repairs greater than 50 mm, formwork was installed, and micro-concrete was applied. Figures 8 and 9 show crack repair using epoxy injection and spalling repair with micro-concrete, respectively.

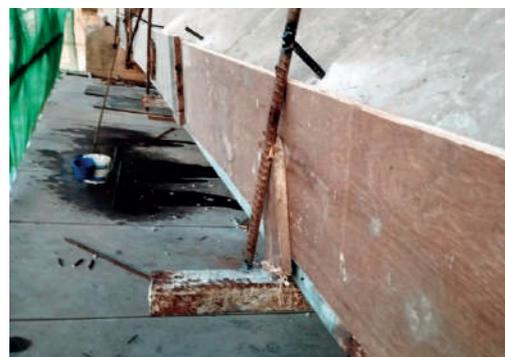
Fig. 9: Spalling repair using Micro-Concrete

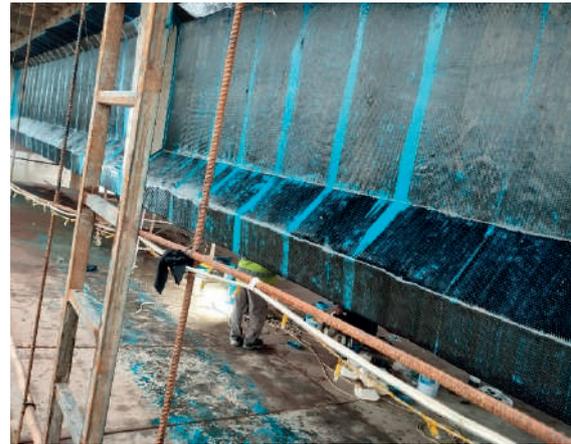
Fig. 12: Strengthening of the girder by installing CFRP fiber wrapping.

For CFRP wrapping, 230-grade CFRP was employed, with an elastic modulus (E_p) of 230 GPa, an ultimate tensile strength (F_{uf}) of 4.9 GPa, and an elongation of 1.5%. The ply thickness is 0.112 mm. Fig. 12 illustrates the strengthening of the girder through the installation of CFRP fiber wrapping.

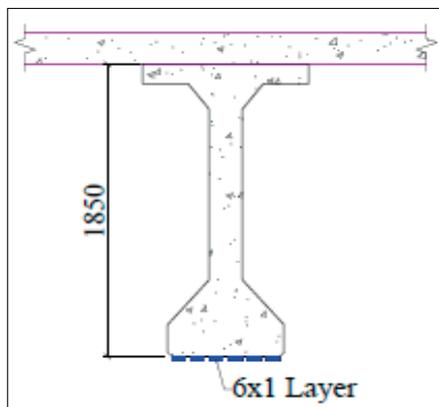
Fig. 10: (a) The plan and (b) girder section show FRP strengthening through fiber lamination and fiber wrapping

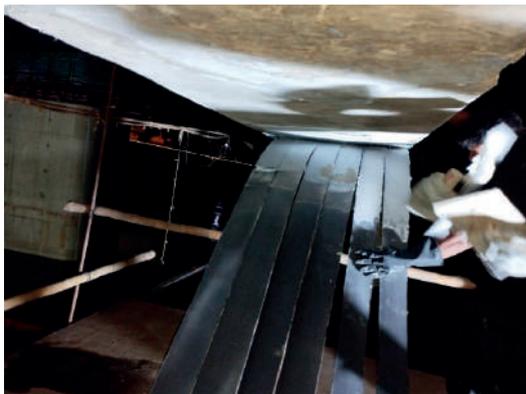
Fig. 11: Strengthening by Installing CFRP Laminates

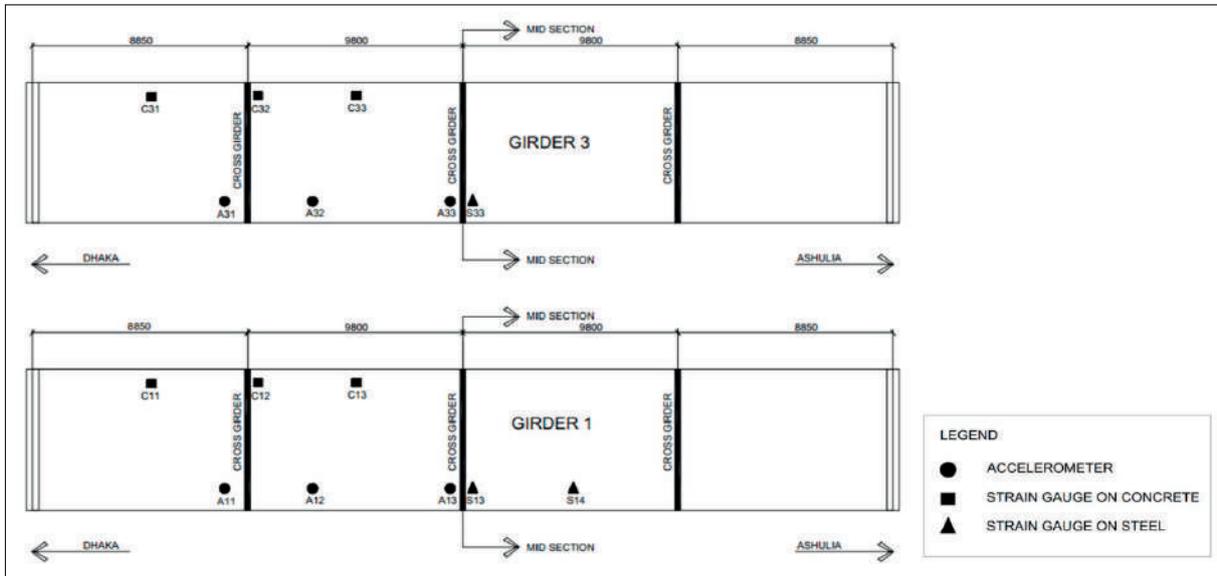
Unidirectional Integrated Circuit Piezoelectric (ICP) accelerometers were installed at three positions on the third span, specifically on the damaged first girder from the north side and the middle girder. Fig. 13 shows a schematic view of the accelerometer and strain gauge locations on both girders. The vertical acceleration of the girders was recorded at six points under two

Fig. 13: Schematic view of the accelerometer position

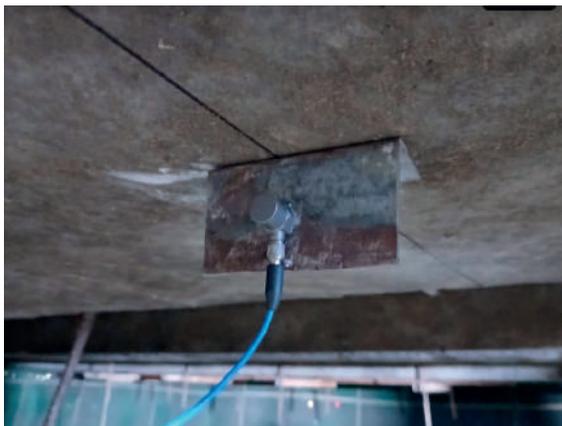
different loading conditions. Fig. 14 shows how the accelerometers were attached to the girders for the test.

Fig. 14: ICP Accelerometers attached to the girders

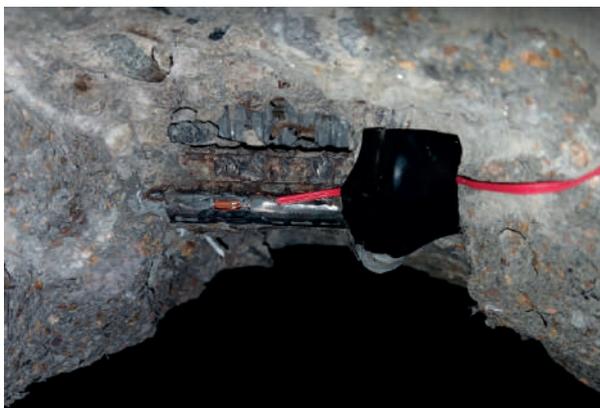
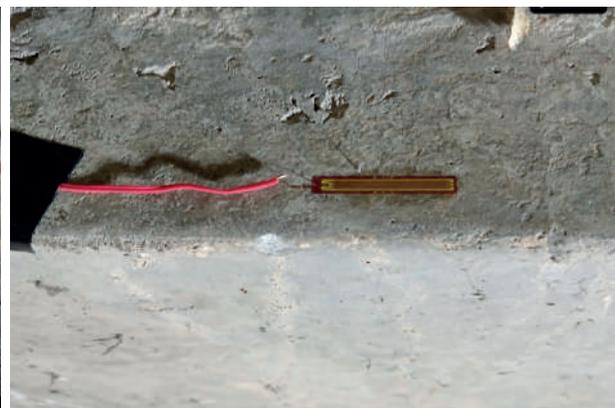
The strain gauges used in these tests to measure concrete strain were models KFGS-5-120-C1-11-L3M2R and KFGS-30-120-C1-11-L5M2R, both manufactured by Kyowa Electronic

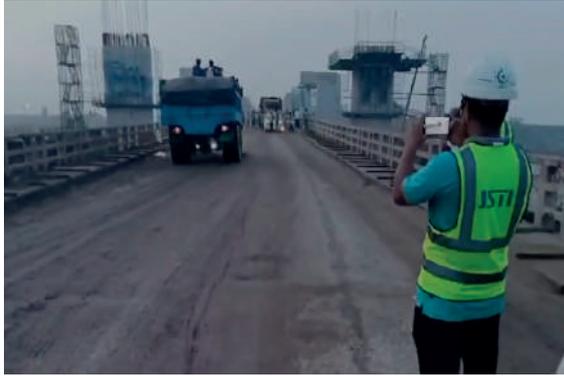
To study the dynamic effects on the damaged bridge span, a truck with a gross weight of 22,365 kg was used. During the dynamic loading tests, the truck moved at a constant speed of 10 km/hour across the span.

Fig. 16: Truck used for the test

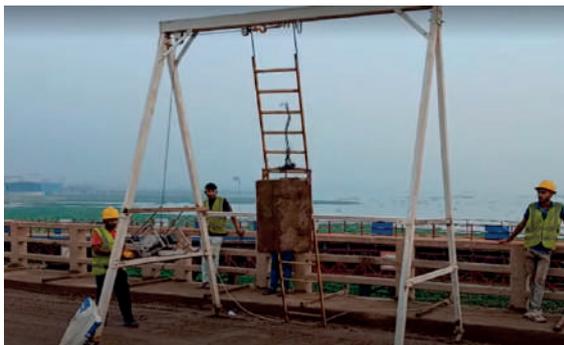
A heavy object weighing 512 kg was released from a height of 5 feet (9m from mid-point of the span on the 2nd girder) to perform the impact load test. Fig. 17 shows the object used for the impact load test.

Fig. 17: Heavy object being dropped for the impact load test

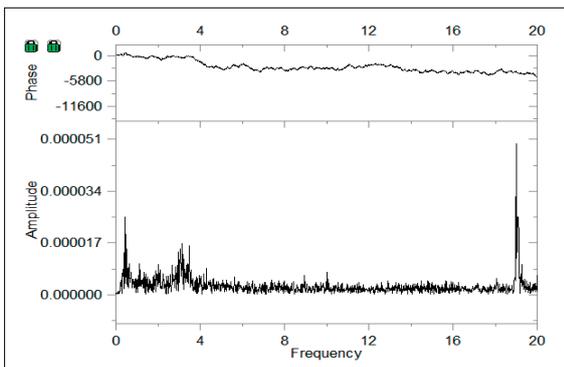
Fig. 18: Frequency spectrum of acceleration at the midpoint of the first girder (A13) under ambient conditions

All the bridge response data for different loading conditions were recorded in a computer using a data logger for further analysis. Figures 18 to 23 show the frequency spectra of acceleration data at the midpoints of both girders under three different conditions. In all these frequency spectra a common peak is found around 3.43 Hz.

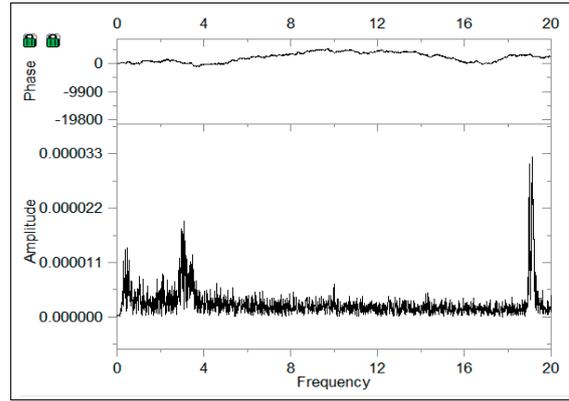
Fig. 19: Frequency spectrum of acceleration at the midpoint of the middle girder (A33) under ambient conditions

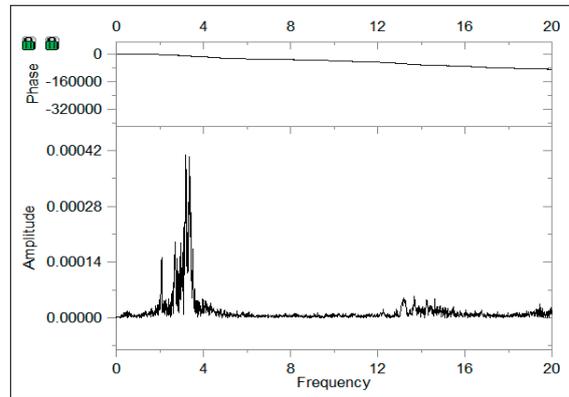
Fig. 20: Frequency spectrum of acceleration at the midpoint of the first girder (A13) under dynamic conditions

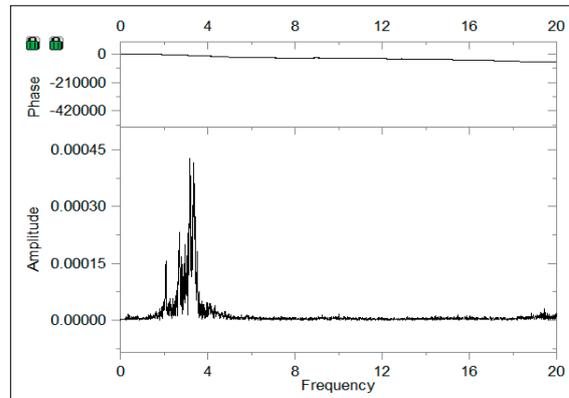
Fig. 21: Frequency spectrum of acceleration at the midpoint of the middle girder (A33) under dynamic conditions

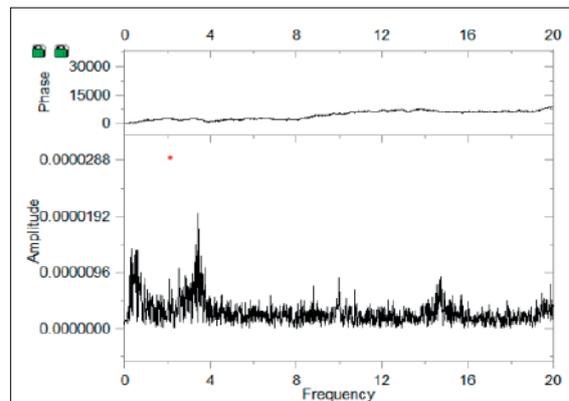
Fig. 22: Frequency spectrum of acceleration at the midpoint of the first girder (A13) under impact loading

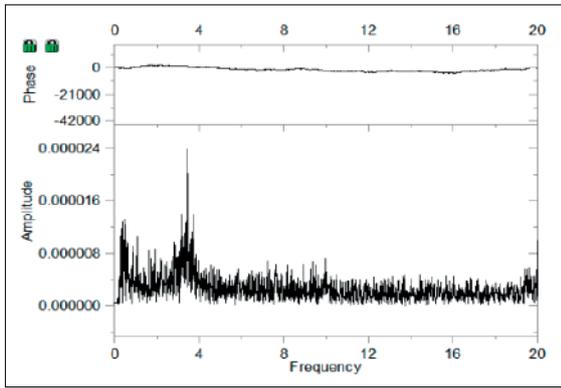
Fig. 23: Frequency spectrum of acceleration at the midpoint of the middle girder (A33) under impact loading

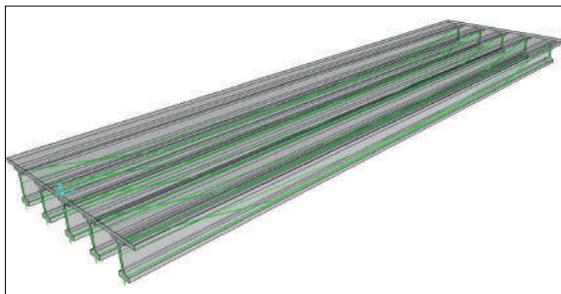
Fig. 24: Repaired bridge model on CSiBridge

To validate the experiment, an analysis was conducted using CSiBridge v26.0.0 and Midas Civil 2021 software packages. The bridge was modeled under three different conditions: free vibration, truckload, and impact load, in order to calibrate the model using the results of the field testing. A 20% effective pre-stress loss was assumed to account for the damage sustained. Fig. 24 shows a 3D view of the finite element model of the bridge.

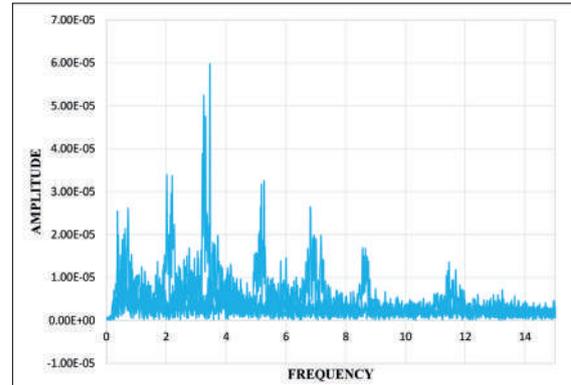
Fig. 25: Ambient vibration response of both girders

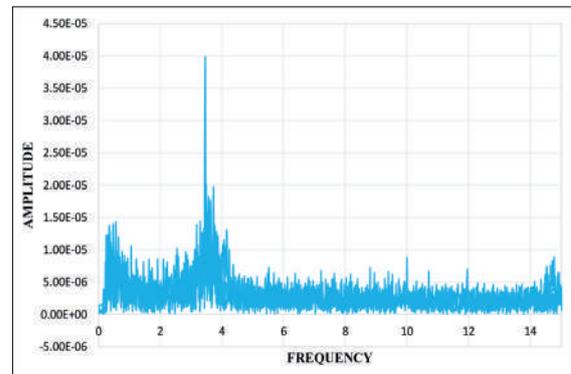
Fig. 26: Free vibration response after impact

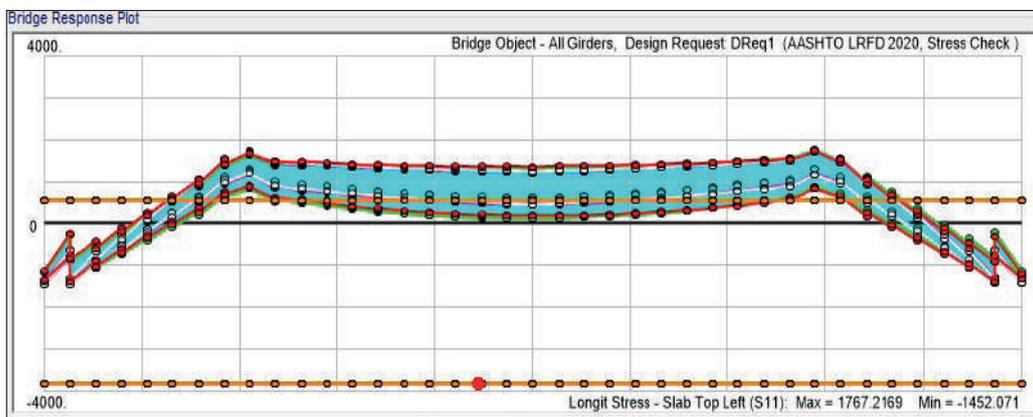
Fig. 27: Stress exceeds the limit at the left Girder for AASHTO standard truck (HL-93k truck)

A time history analysis was initially performed on the bridge using the AASHTO standard HL-93K truck loading. The analysis revealed that stress limits were exceeded at critical sections of the bridge (Fig. 27). These results

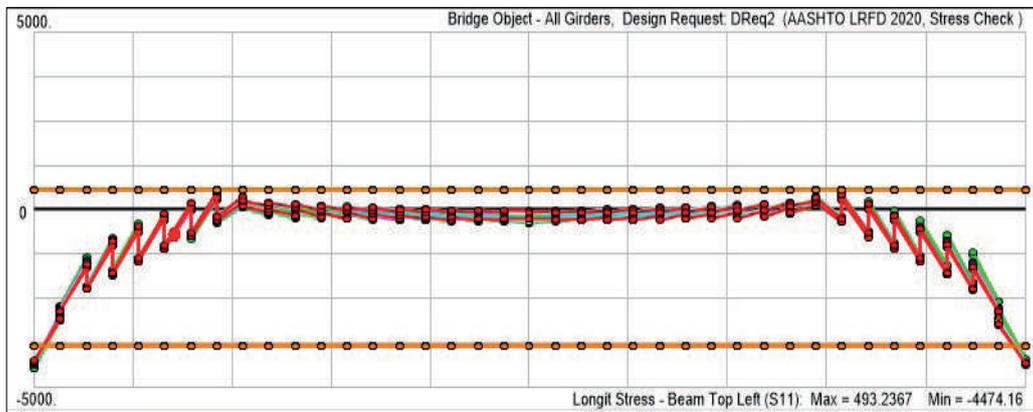
Fig. 28: Stress within the limit at the left Girder for 20-ton truck

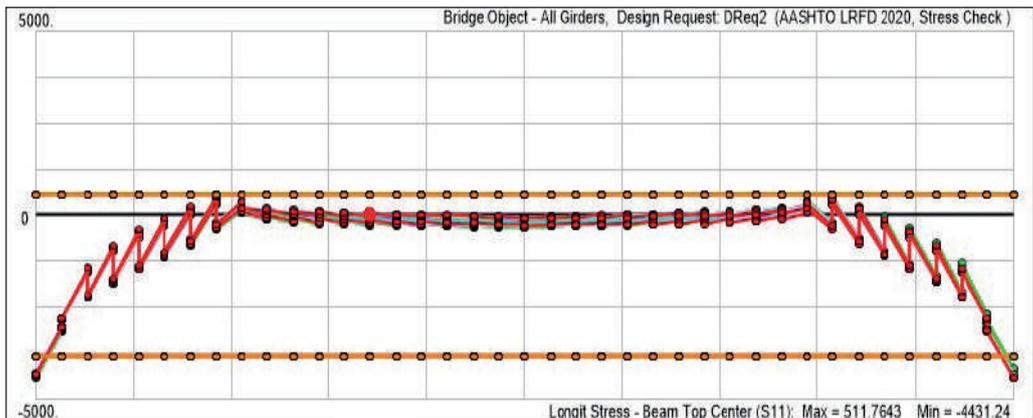
Fig. 29: Stress within the limit at center Girder for 20-ton truck

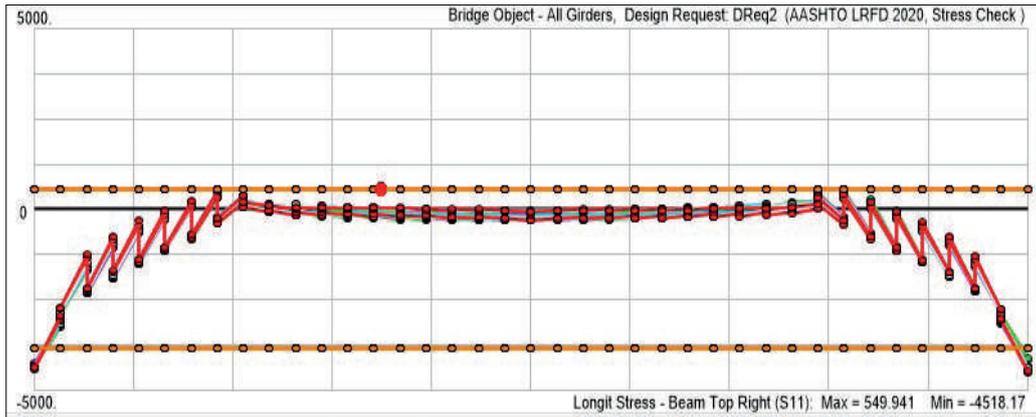
Fig. 30: Stress within the limit at right Girder for 20-ton truck

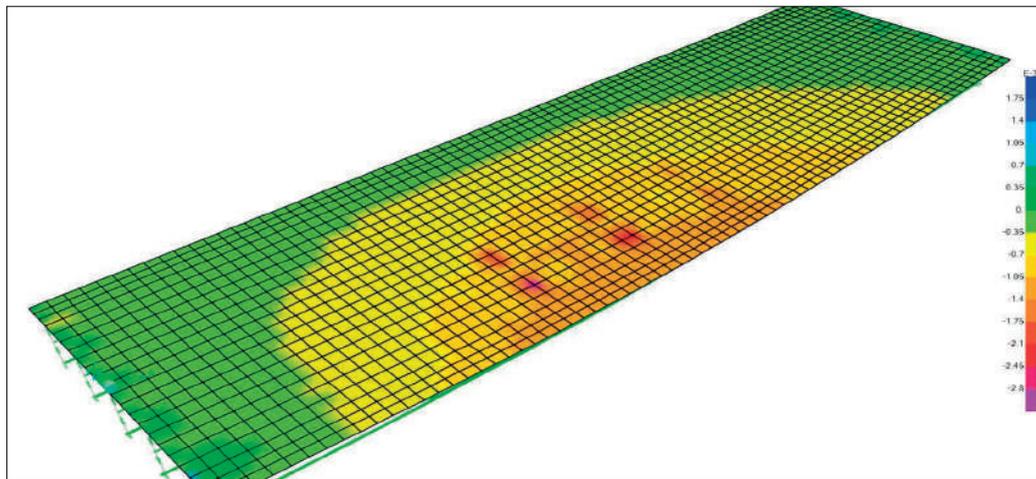
Fig. 31: Stress distribution for 20-ton truck

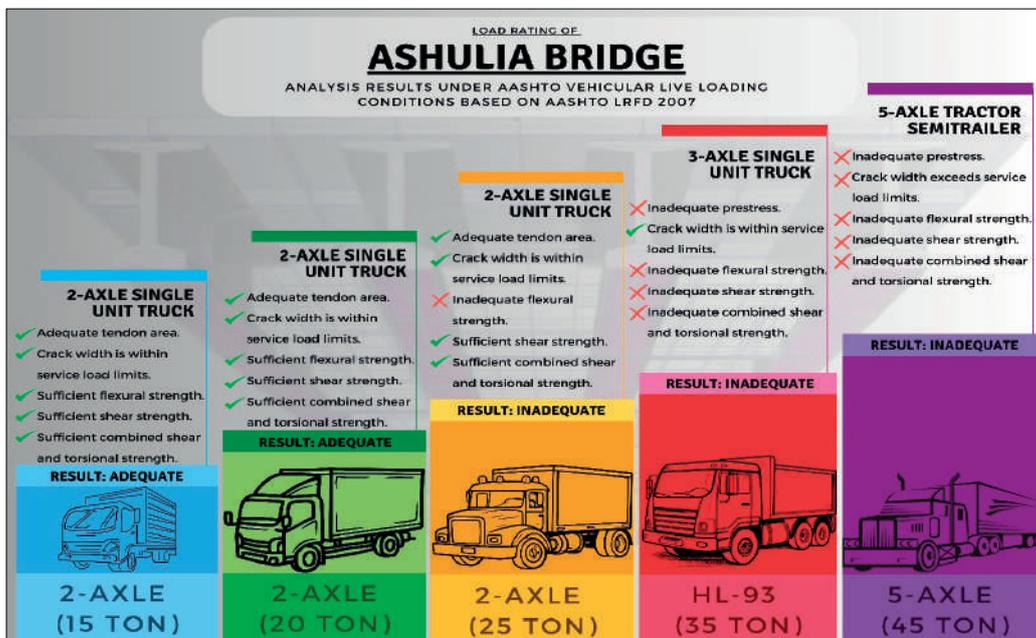
Fig. 32: Load rating chart under different truck loading conditions for the Ashulia Bridge

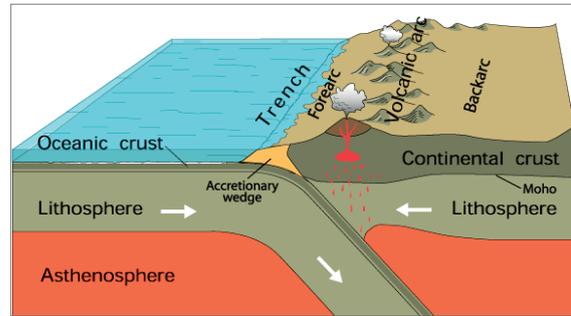
Fig. 2: General diagram of an oceanic subduction zone (Source - Tsunami Generation from the 2004 M=9.1 Sumatra-Andaman Earthquake | U.S. Geological Survey (usgs.gov))

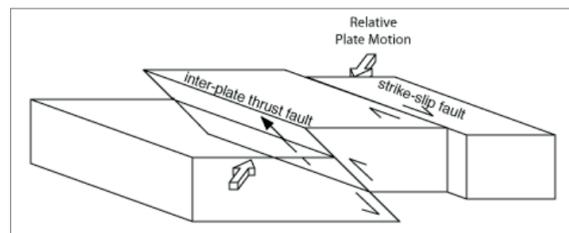
3b. Decoupled faulting

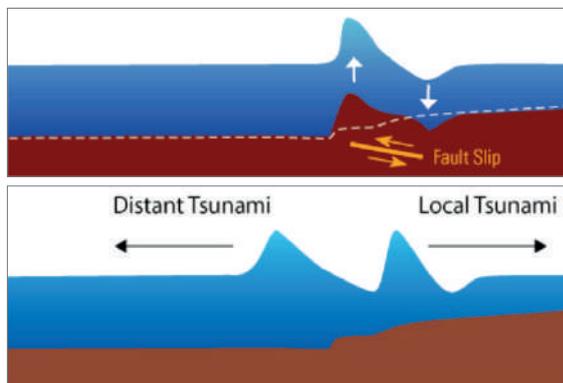
Fig. 4: Schematic diagram of tsunami generation and splitting (Source - Tsunami Generation from the 2004 M=9.1 Sumatra-Andaman Earthquake | U.S. Geological Survey (usgs.gov))

The tsunami from the Sumatra-Andaman earthquake was primarily caused by vertical displacement of the seafloor, in response to the slip on the inter-plate thrust fault. The seafloor on the overriding Burma plate deformed vertically, uplifting seaward toward the trench and subsiding landward toward the coastline. Vertical displacement of the water column approximated that of the seafloor below, resulting in the initial “N-shaped” tsunami wave that was typically generated by subduction earthquakes. This N-wave then split into two, resulting in a pair of N-waves traveling in opposite directions – the distant tsunami, propagated outbound across the Bay of Bengal towards India and Sri Lanka, eventually reaching the Atlantic and Pacific Oceans and the local tsunami, travelled towards Indonesia, Thailand, and nearby islands in less than an hour. The length of the fault that ruptured during this earthquake was massive, extending from northwest Sumatra north to the Andaman Islands.

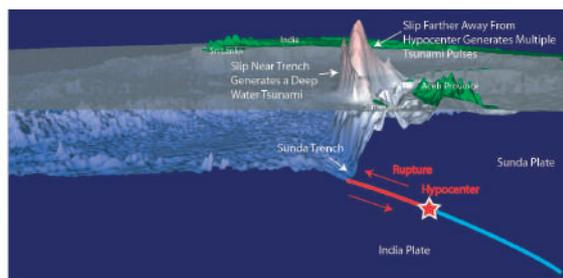
Fig. 5: Sumatra Earthquake Occurrence (Source - Tsunami Generation from the 2004 M=9.1 Sumatra-Andaman Earthquake | U.S. Geological Survey (usgs.gov))

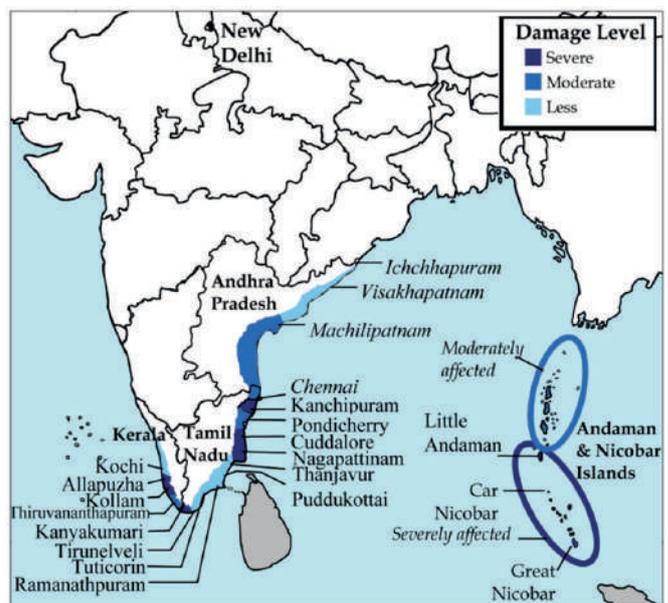
Fig. 7: Map showing relative tsunami-induced damage along the coastal districts and in the islands
(Source - April-05-Sumatra_FINAL4.inidd (nicee.org))

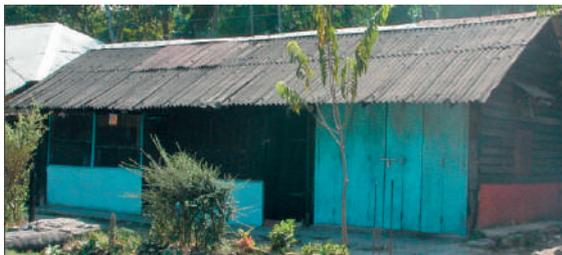
Fig. 8: Single-story wood house in Port Blair with light roof had no damage
(Source - April-05-Sumatra_FINAL4.indd (nicee.org))

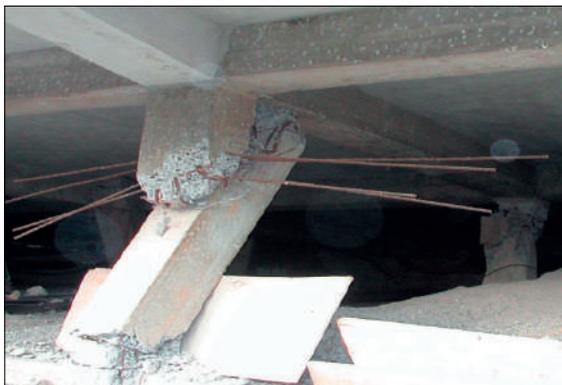
Fig. 9 Three storied RC framed building collapsed
(Source - April-05-Sumatra_FINAL4.indd (nicee.org))

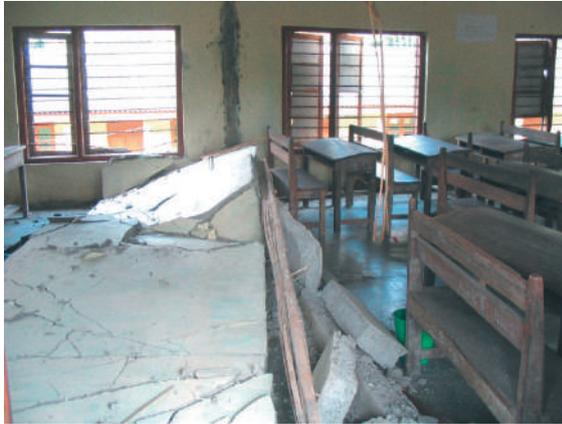
Fig. 11: Slender masonry walls dislodged due to out-of-plane instability

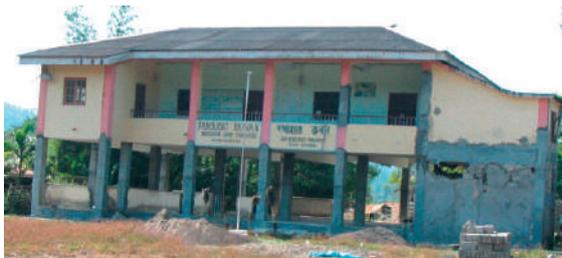
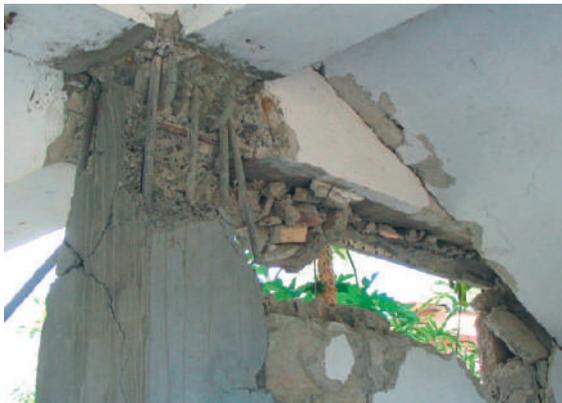
Fig. 12: Building showing severe cracking and damage to soft ground storey

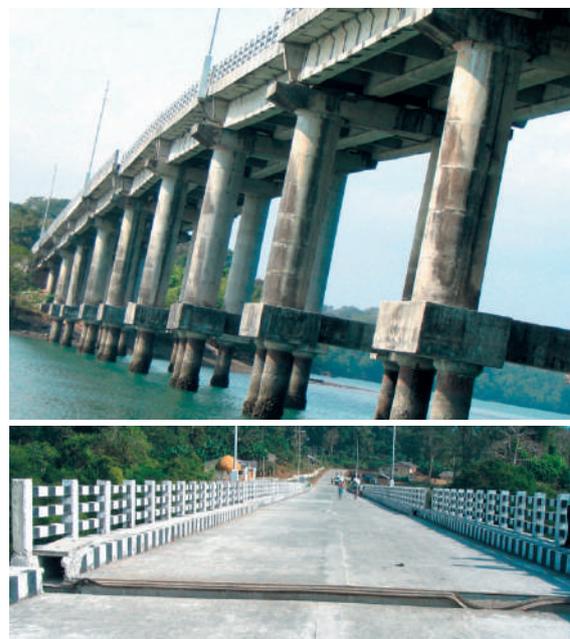
Fig. 13: Bridge over Austen Strait was rendered dysfunctional (Source - April-05-Sumatra_FINAL4.indd (nicee.org))

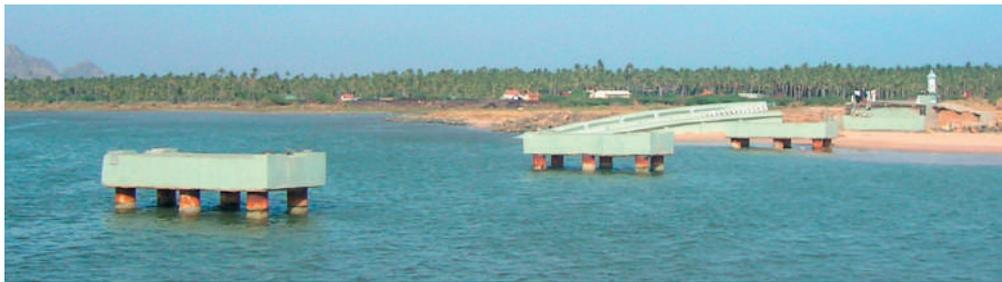
Fig. 14: Loss of spans of the four span RC bridge at Melmannakudi in Tamil Nadu
(Source - April-05-Sumatra_FINAL4.indd (nicee.org))

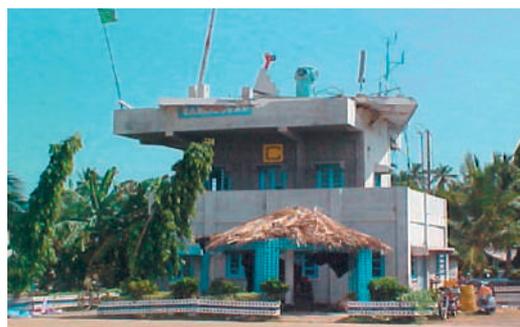
Fig. 15: Partial-collapse of the upper story of the air traffic control tower at airport
(Source - April-05-Sumatra_FINAL4.indd (nicee.org))

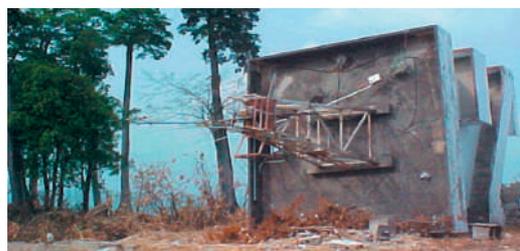
Fig. 16: Laterally toppled three-story seaport traffic control tower at Hut Bay
(Source - April-05-Sumatra_FINAL4.indd (nicee.org))
