Vol. 04 | November 2023

# Seismic

JOURNAL

### Repair And Rehabilitation Of Admin Block In School Building

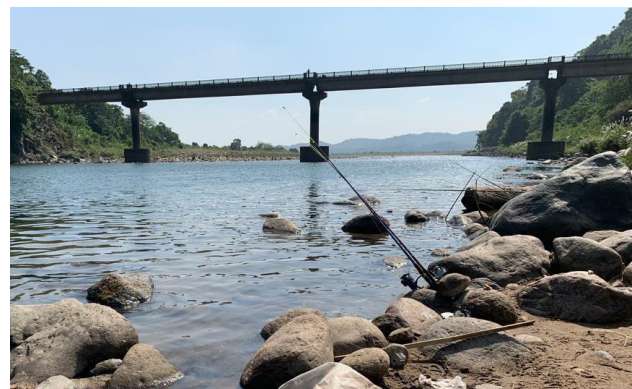
Figure 1:  
Total length 150 Meter with 4 Spans of 37.5 meter each

Bridges are the lifeline of any region and aging and degradation of transportation infrastructure pose significant safety concerns, with increase in the vehicular traffic on such bridges, for which, they were not designed. The structural health assessment of such old bridges are very important and involves a process starting from a visual inspection to detailed non-destructive test programme without affecting the flow of the traffic during such exercises. The bridges in the state of Meghalaya are mostly in deep valley connecting otherwise inaccessible mountains and hills and assessment and monitoring of such high bridges are challenging for the engineering departments. The bridge No. 5/5 at Umngi River (Umpung) on Balat Bagli Road is one such bridge, which was built about 60 years before by the Public Works Department of the undivided Assam. The bridge is 150 m long in total with 4 spans of 37.5 m each resting on tall piers of average 1.75 m diameter, sitting on well foundations as shown in Fig. 1 and 2. The pier above the well TOC is about 8.4 m up to the pier head as shown in Fig. 2.

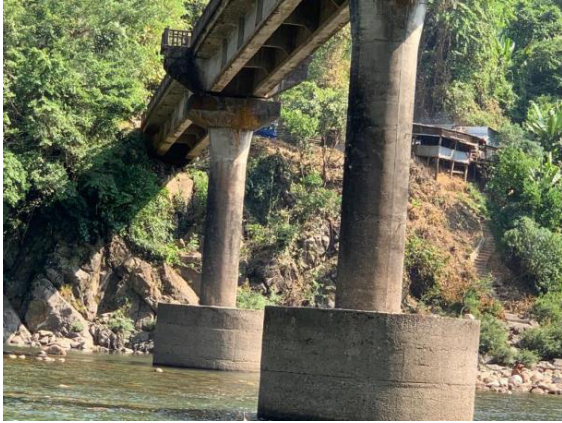
Figure 2: Pier heights are 8.4 meter each

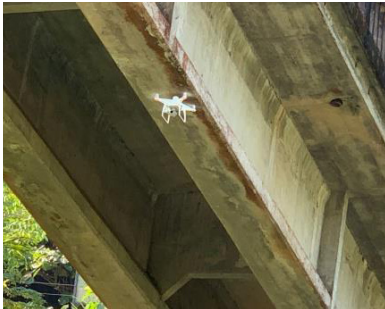
Figure 3: Drone Survey at the site for RVS with remote access

The application of drones have been seen in various areas now a days and remotely controlled drone (Figure 3) was used in extensive initial inspection to access difficult areas, locations and surfaces to accomplish the initial Rapid Visual Screening ( RVS) of the bridge. The visuals were streaming from the drone camera to a hand-held station / data logger and the necessary assessment photographs were captured and stored for subsequent detailed studies. It was thereby possible to access and visually inspect locations, which were otherwise not assessable physically.

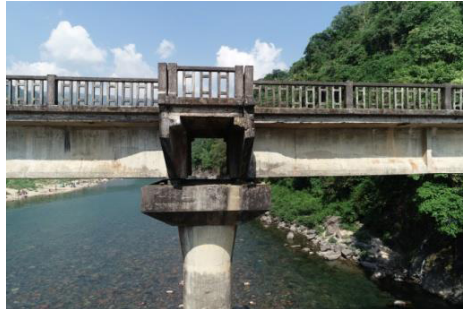
Figure 4: Drone accessing difficult locations for RVS - Pier Top

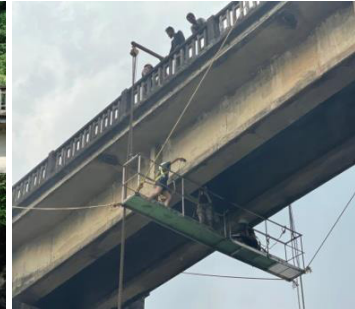
Figure 5: Suspended platform for physical access and NDT at site

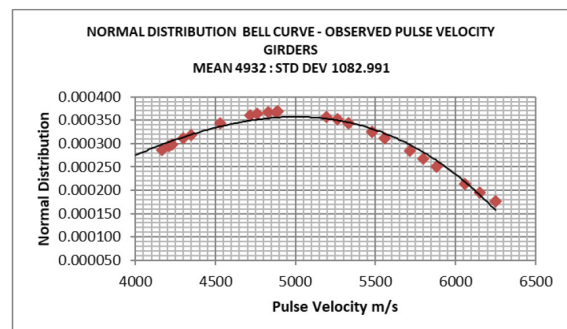
Figure 6:

Normal Distribution of the observed USPV data in the girders of the bridge. The quality of concrete in all the girders were found to be of excellent quality as per NDT data.

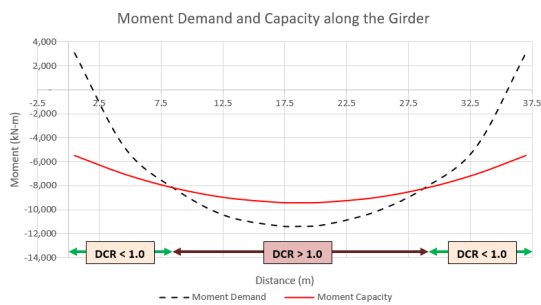
Figure 9: Comparing Moment Demand vs Capacity along the span of the girder

- For girder sections near and around mid-span, it is observed that the moment

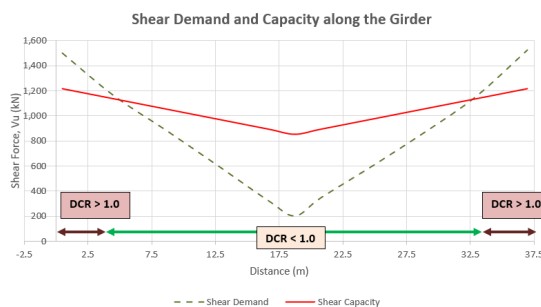
Figure 10: Comparing Shear Demand vs Capacity along the span of the girder

To estimate the bending strength of the pre-stressed girder, a moment-curvature analysis is performed for girder sections at 6 different locations along the span of the bridge. The maximum moment capacity is then plotted along the length of the girder to obtain the capacity curve, which is then compared with moment demand curve as shown in Figure 9. Similarly, the shear demand and capacity for the girder is calculated and compared as shown in Figure 10.

- For girder sections near support, it is observed that the shear demand is greater than the capacity of the girder. Strengthening of girders using Carbon Fibre Reinforced Polymer (CFRP) Wraps is thus explored.

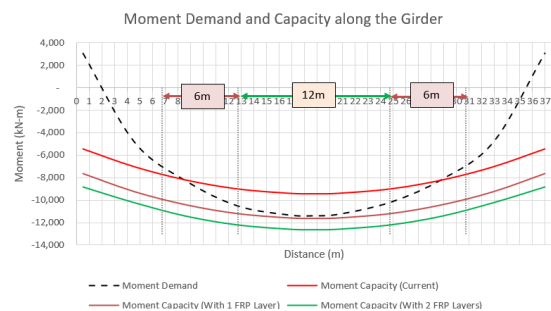
Figure 11: Comparing Moment Demand vs Capacity along the span of the girder (before and after strengthening)

From Figure 11, it is advised to provide 2 layers of CFRP Laminates along the mid 12-meter span of each girder, and 1 layer of laminate for an additional 6 meters on each side. Figure 12 shows the resultant moment capacity of the girder (after strengthening) and compares with the demand moment.

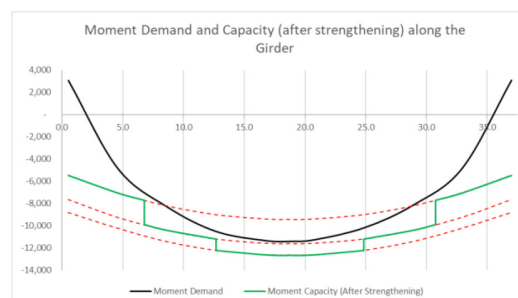
Figure 12: Comparing Moment Demand vs Capacity along the span of the girder (before and after strengthening)

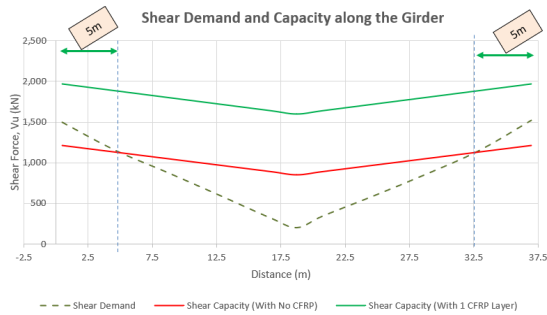
Figure 13: Comparing Shear Demand vs Capacity along the span of the girder (both with and without CFRP)

Carbon Fibre Reinforced Polymer (CFRP) wraps are used to increase the shear capacity of the girders. Figure 13 shows the increase in shear capacity of the girder strengthened with CFRP wrap. It is advised to provide 1 layer of CFRP wrap along both sides of the girder for a distance of 5 meters from the support.

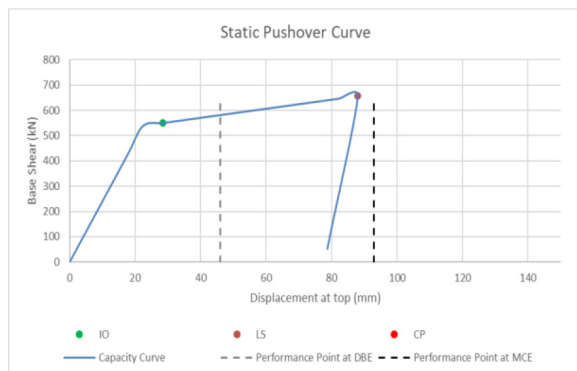
Figure 15: Static Pushover Curve for the Bridge Pier

Based on the results of Static Pushover Analysis, it is observed that the pier fails to achieve its performance objectives. Thus, Strengthening

Seismic Demand	Target Performance Level	Target Displacement	Hinge Status	Remarks
DBE	IO	46mm	IO-LS	Target performance not achieved. Strengthening of Pier is recommended.
MCE	LS	93mm	> CP	Target performance not achieved. Strengthening of Pier is recommended.

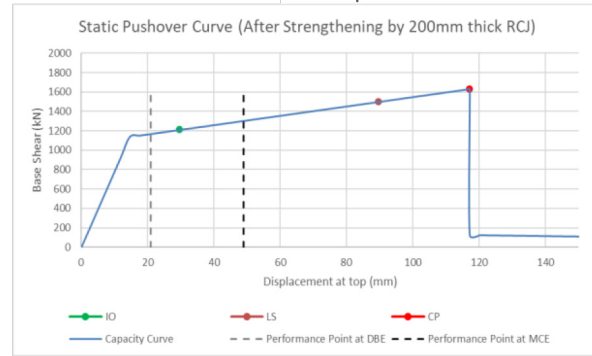
Figure 17: Static Pushover Curve of the Bridge Pier Strengthened with Reinforced Concrete Jacket

Figure 17 shows the Static Pushover Curve (Capacity Curve) for the bridge pier strengthened with 200mm thick reinforced concrete jacket. It is observed that after strengthening by Reinforced Concrete Jacket (RCJ), the pier successfully meets its performance objectives.

Seismic Demand	Target Performance Level	Target Displacement	Hinge Status	Remarks
DBE	IO	15mm	<IO	Target performance achieved. Strengthening of Pier is successful.
MCE	LS	34mm	IO - LS	Target performance achieved. Strengthening of Pier is successful.

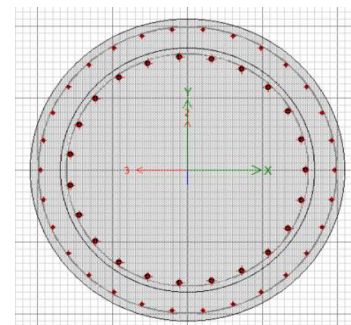
Figure 16: Cross section of RC jacketed pier as defined in computational model

by Reinforced Concrete Jacketing (RCJ) is recommended to improve the performance of the pier. Reinforced Concrete Jacketing improves column flexural strength and ductility. For strengthening of the pier, a 200mm thick reinforced concrete jacket (as shown in Fig. 49) is added around the existing pier.

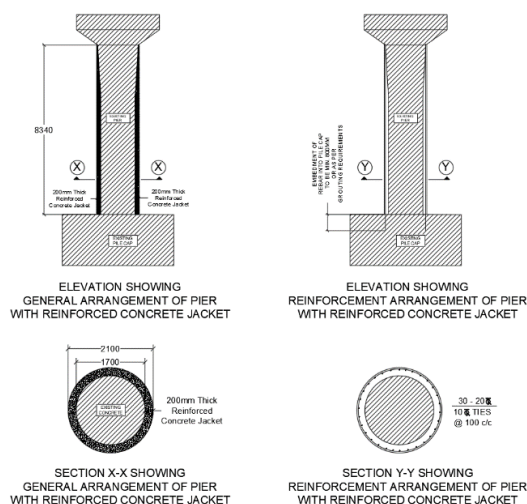
Figure 18: Strengthening of Bridge Pier by Reinforced Concrete Jacketing

Thus, Strengthening by Reinforced Concrete Jacketing (RCJ) is found to be effective in improving (and achieving) the performance of the pier.

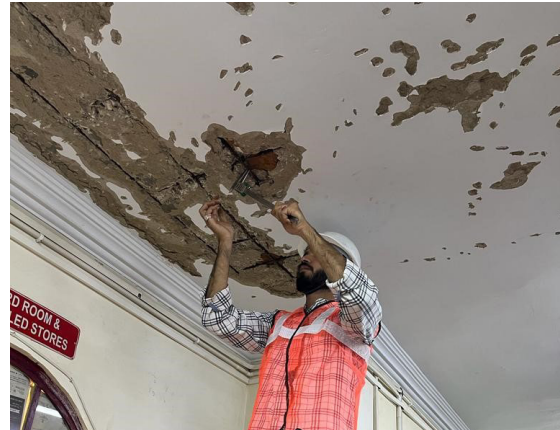
Fig.1 – Deteriorated ground floor roof slab

This case study comprises the details of the repair and rehabilitation of the admin building in a school situated in the central part of Rajasthan. It is a two-story building constructed about 35 years back, and the ground floor roof has deteriorated significantly, as shown in Fig. 1. Texel Consulting Engineers Pvt Ltd was appointed for the engineering part of this rehabilitation project. Engineers from the company conducted a site visit and encountered challenges such as the absence of drawings, a lack of information regarding the structural components, time constraints,

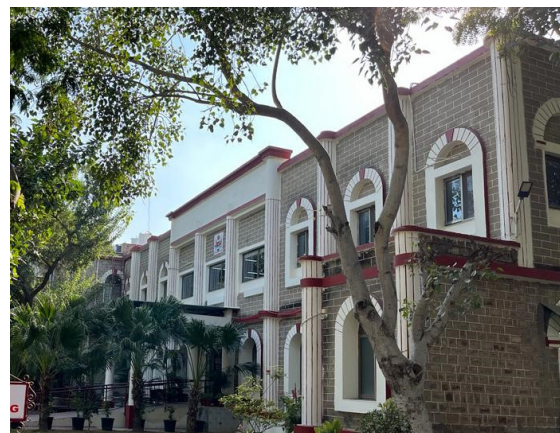
Fig.2 – Exterior view of the building

and the need for minimal demolition. Upon visual inspection, the structure appeared to be a frame structure, as illustrated in Figure 2. However, upon closer examination, it was revealed that the columns in the elevation were constructed using stone masonry for aesthetic reasons.

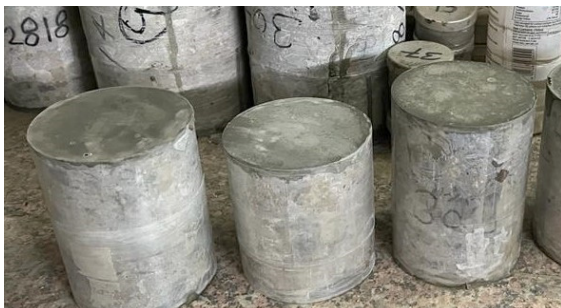
Fig.4 – Extracted core and prepared sample

In line with the procedure above, engineers conducted comprehensive measurements of the entire building, including masonry wall dimensions and beam-slab details. Non-destructive testing (NDT) methods, such as rebound hammer and ultrasonic pulse velocity (UPV), were employed to evaluate the concrete quality. Additionally, core samples were extracted to assess the closest compressive strength, as depicted in Fig. 4. Visual assessment of slab reinforcement was carried out in exposed areas, including measurement of reduced diameters using a vernier caliper. For areas where the reinforcement was not exposed, an instrument called HILTI Ps-200 was utilized to gather reinforcement information, as shown in Fig. 5.

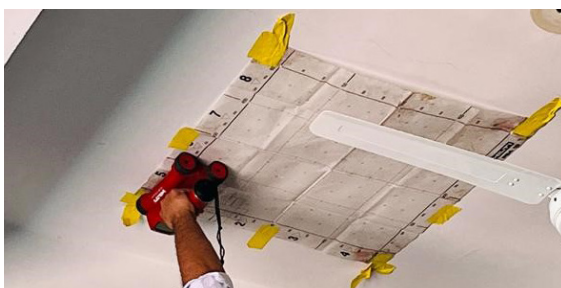
Fig.5 – Mapping by HILTI PS-200

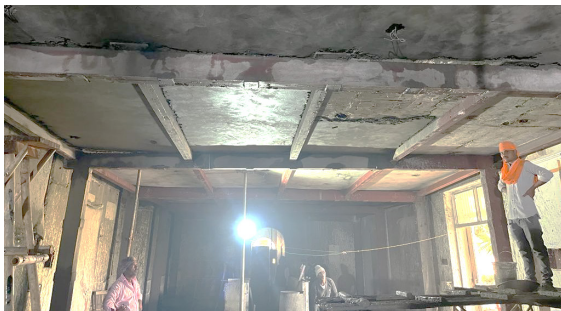
Fig.8 – Structural Steel frame

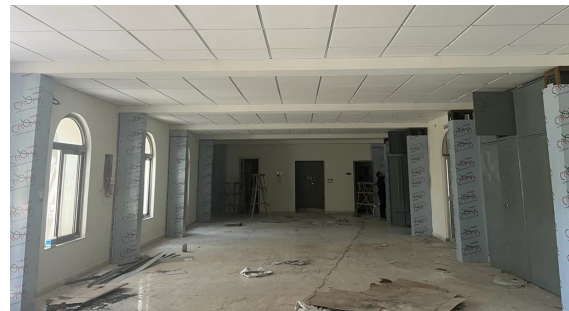
Fig.9 – Finished after strengthening

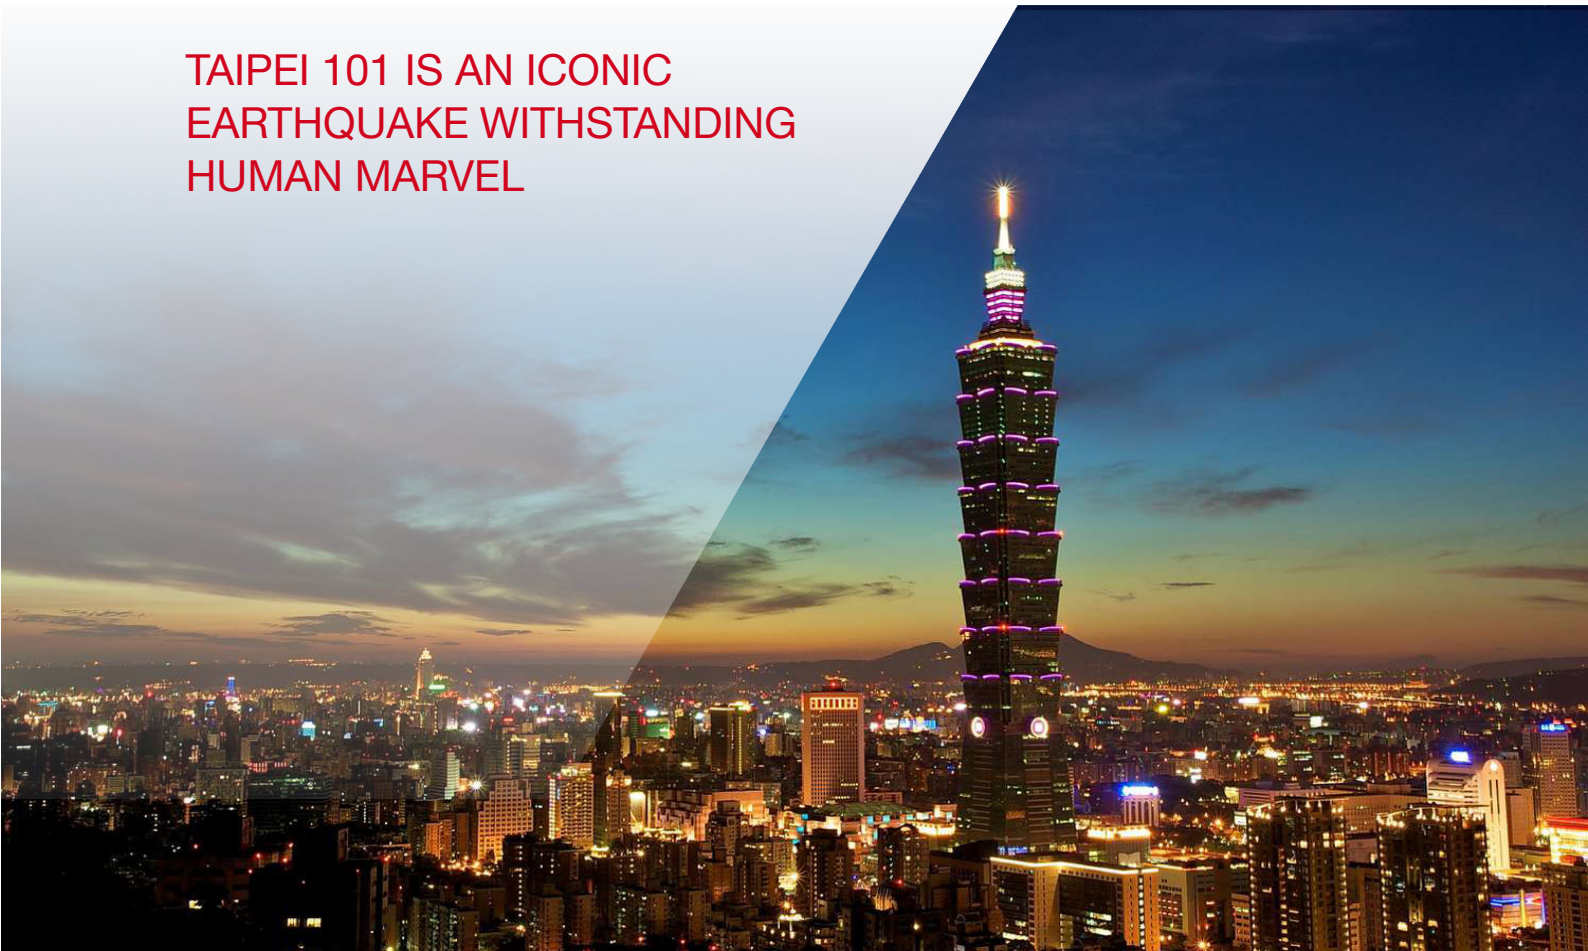
### TAIPEI 101 IS AN ICONIC EARTHQUAKE WITHSTANDING HUMAN MARVEL

Formerly known as the Taipei Financial Center, Taipei 101 is an office building in Taipei, Taiwan, standing 508 m tall. When it was completed in 2004, it dethroned the Petronas Twin Towers in Kuala Lumpur Malaysia, 452 m as the tallest building in the world.

Designed by C.Y. Lee & Partners, a local architectural firm and structural consultants from Thornton-Tomasetti Engineers, New York City and Evergreen Consulting Engineers; Taipei 101 is an iconic structure, engineered to withstand strong earthquake tremors as well as powerful typhoons that wreak havoc in Taiwan. It is designed to be resilient against gale winds of 134 mph and the strongest earthquake with an estimated return period of 2,500 years. This performance is mainly attributed to the 660 tonne steel pendulum that serves as a tuned mass damper.

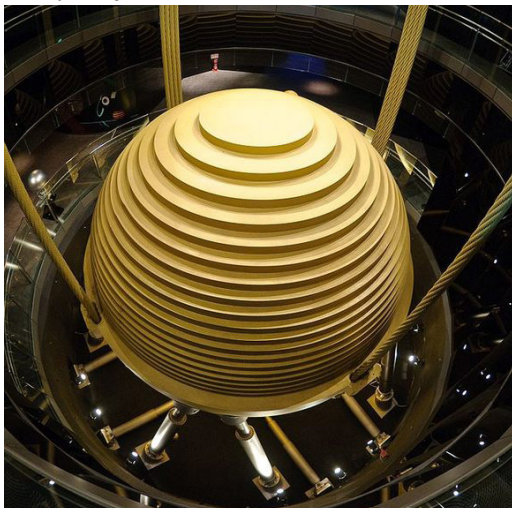
The pinnacle presented further engineering difficulties. The pinnacle is vulnerable to crosswind excitation due to its uniform cylindrical shape and location on top of a building. With many more cycles at lower stresses accumulating at low wind speeds, three mode forms were found to have the ability to produce substantial stress ranges during storms. Due to these circumstances, fatigue life was a crucial design factor for the steel-trussed pinnacle spine. There were two strategies for reducing fatigue. First, local supplemental dampening was applied to lessen dynamic response. In addition to the building's primary TMD, Motioneering, of Guelph, Ontario, designed two ingenious compact TMDs to be placed within the uppermost 8 m of the pinnacle. Each has a 4.5 Mg (5 ton) steel mass that can slide on rollers horizontally along two axes, like a bridge crane traversing the width and length of a factory bay. The TMDs are "tuned" with vertical precompressed spring sets tied to the masses through flexible cables and pulleys. Two TMDs are needed due to the multiple oscillation modes that can excite the pinnacle.
